Applies To: **2003 Pilot EX** – From VIN 2HKYF18..3H500001 thru 2HKYF18..3H604126

## 2003 Pilot: Rear Blower Motor Does Not Work

(Supersedes 03-048, dated August 19, 2003)

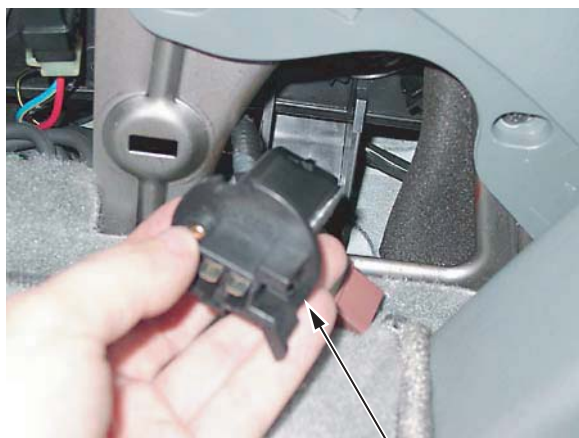
REAR POWER TRANSISTOR

The power transistor for the rear blower has an open circuit.

6. Pull out the power transistor.

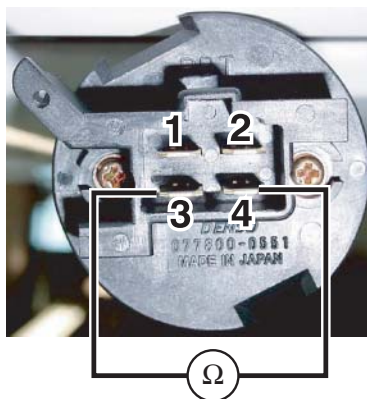
Is the resistance more than 1MΩ (1,000,000 ohms or open)?

NOTE: Power transistor temp should be between 32°F and 130°F before checking.

7. Check the resistance between pins 3 and 4.

**YES** — Replace the power transistor (go to REPAIR PROCEDURE).
